JSC “SPORTINĖ AVIACIJA”	Page 3
Service Bulletin No. 019.8.Re.009A	Pages 4

1. Subject: Extension of the approved life time from 1500 flight hours to 3000 hrs.

Type: LAK-19

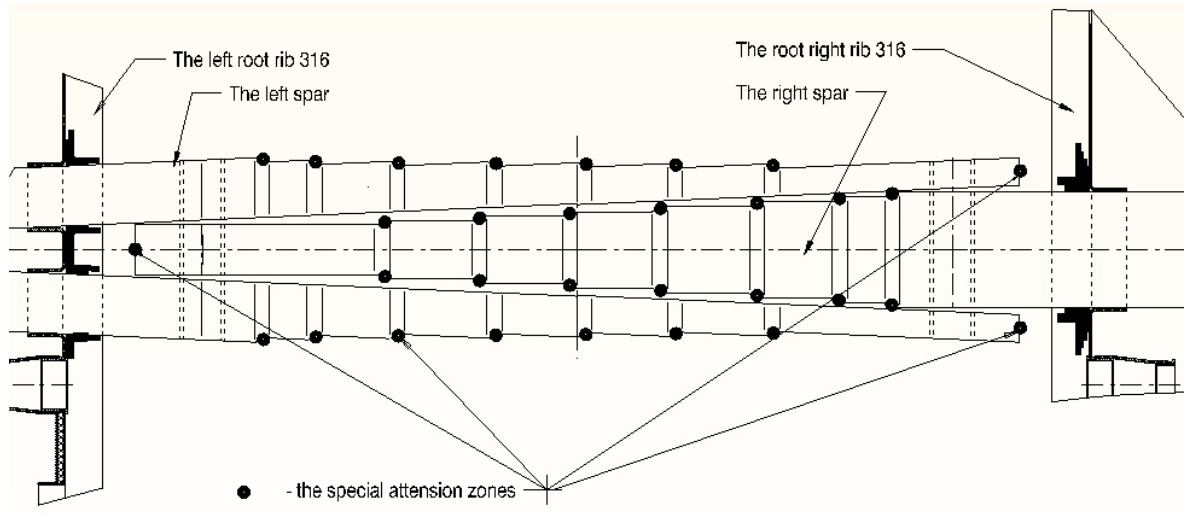
Fig.1. The wing spar.

14. To check surfaces of ends of wing spars (Fig.1), surfaces of external wing root ribs, paying special attention to connection zones of root ribs to spar ends and wing shells. If there are some splits or other damage on glass fiber reinforced plastics it is necessary to repair the damaged place.

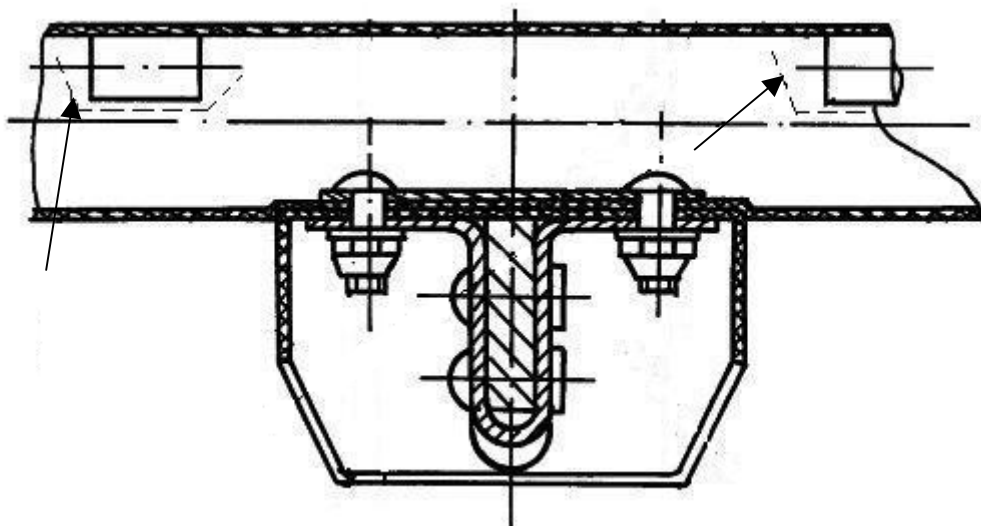
- a) the surfaces around hinge joints of control unit of elevators on the horizontal tail.

In zones where paint has cracks it is necessary to clean off the paint and check glass fiber reinforced plastic for cracks and if necessary to repair the damage.

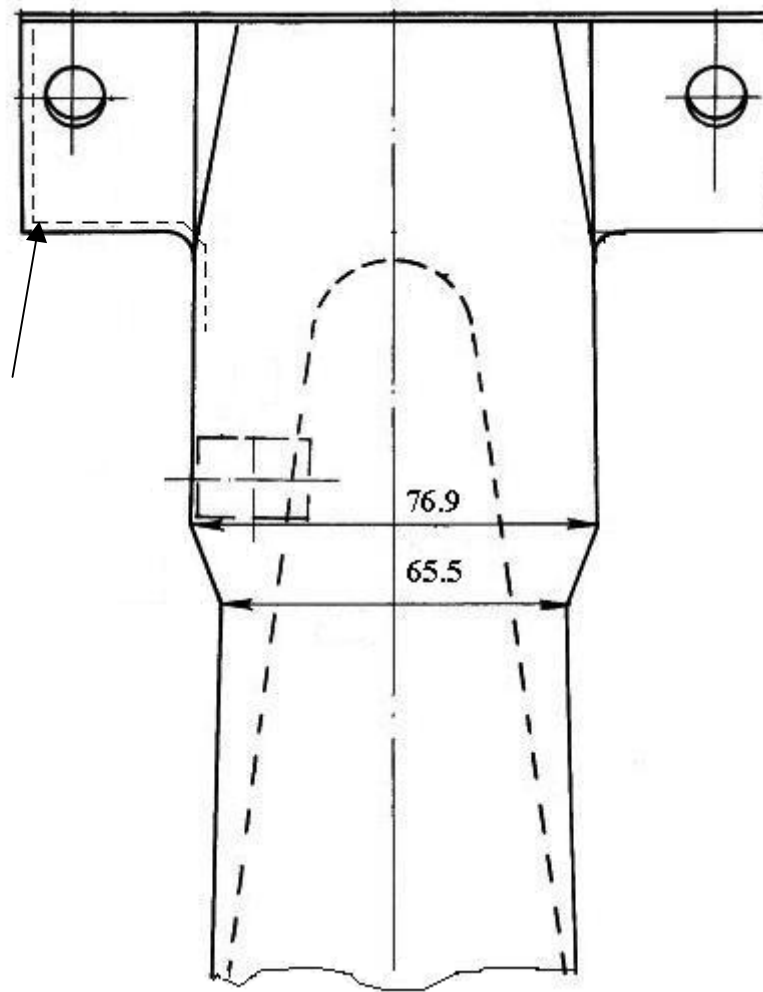
b) the glued zones of the vertical tail spar onto the upper fin part

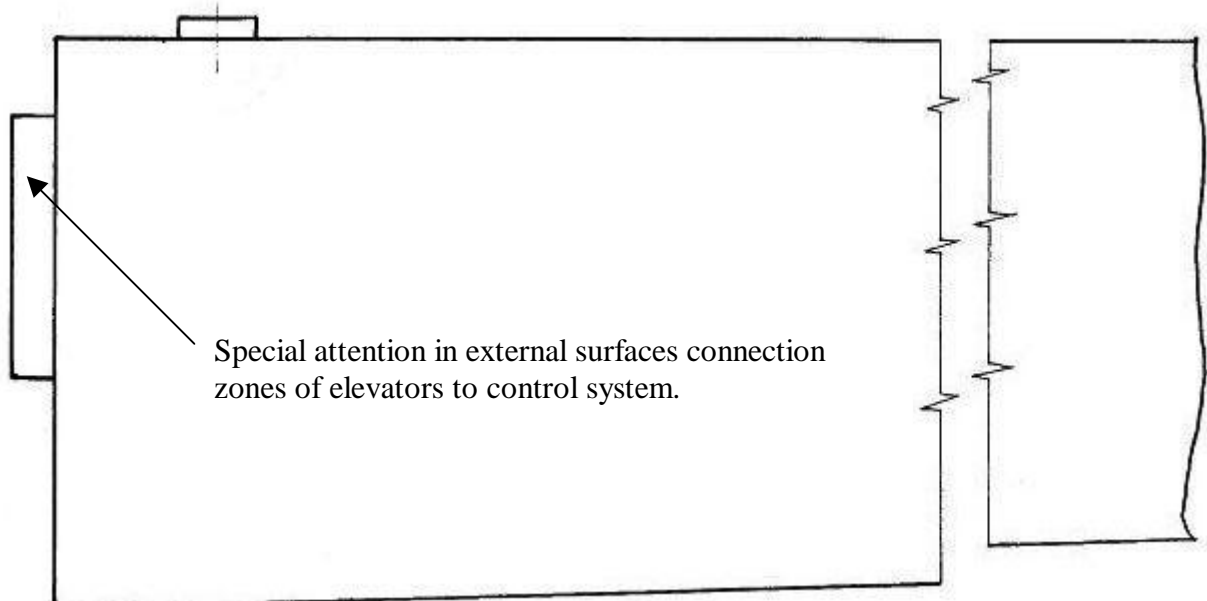
c) the elevator root rib

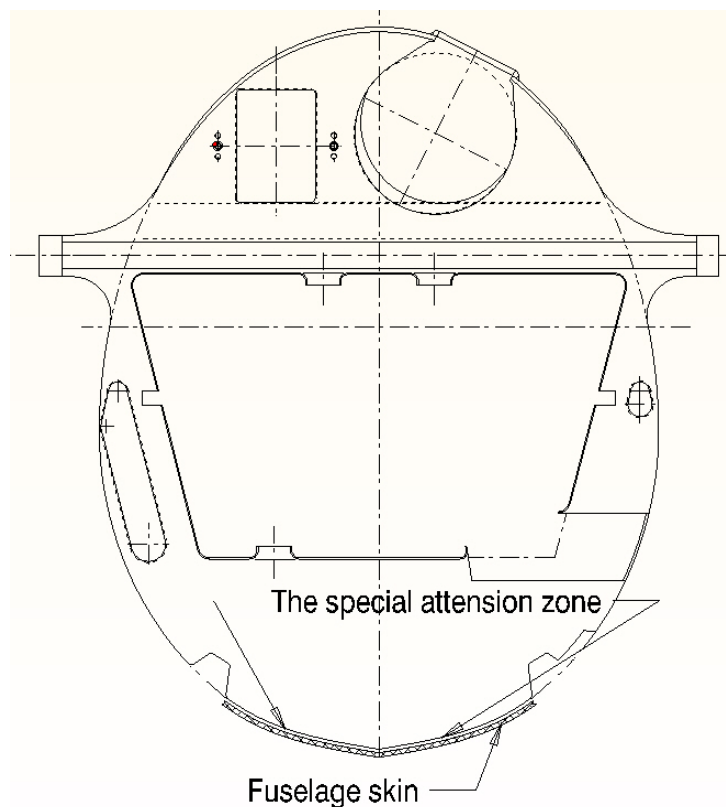
d) the fuselage bulkhead
